#### URGENT MEDICAL DEVICE CORRECTION

## Potential for Suspension of Dynamic Sensing Algorithm

Aurora EV-ICD™ (DVEA3E4) <UDI: 00763000368470>, Clinical EV-ICD (DVEX3E4) <UDI: 00763000217907>

October 2025

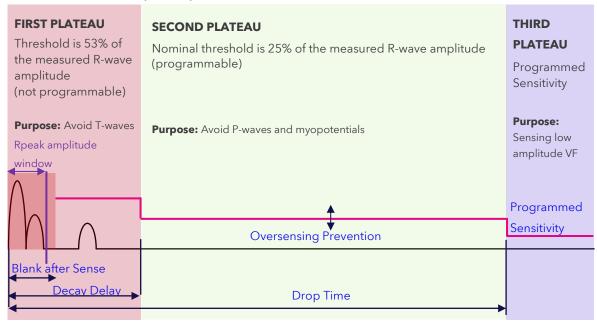
**Figure 1**- Operation of Sensing Thresholds - The first plateau duration ("Decay Delay") is nominally 360 ms, the second plateau duration ("Drop Time") is nominally 1500 ms, and the third plateau lasts until another sensed beat. R-wave amplitude measurements take place during "Rpeak amplitude window" shown above, nominally 128.75 ms (not programmable).

The dynamic sensing algorithm may become suspended at the first plateau if the following sequence of events occurs:

- 1. Charge-end occurs within 128.75ms of the prior sensed beat, thus interrupting the in-progress R-wave measurementsuspension of the dynamic sensing algorithm occurs and the sensitivity plateau becomes static at 53%.
- 2. The sensitivity plateau will remain at 53% until a subsequent **R-wave amplitude exceeds this value.** In case of a significant drop in R-wave amplitude, delay in HV therapy delivery can occur.

Medtronic has implemented manufacturing changes, and devices manufactured with this update are not susceptible to this delay. In previously distributed devices, a device interrogation with the CareLink™ SmartSync™ Aurora EV-ICD™ application (D00U025) on CareLink SmartSync Device Managers will resolve the potential for this behavior (see Appendix B).

- Prophylactic device replacement is NOT recommended.
- Schedule an **in-clinic SmartSync interrogation** to receive the software update, with the intent for all patients to receive the update within **the next 3-6 months**.
